DUTCH  
SAFETY BOARD

# Near mid-air collision between F-16 and Tecnam

*The Hague, October 2025*

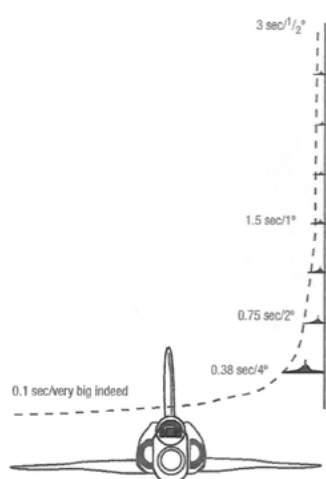
The limitations of the see and avoid principle become even more apparent at higher closing speeds, such as in the case of high-speed military fighter aircraft. Research on this subject shows that, given the speed of a military fighter aircraft, it may only take some seconds before a head-on approaching fighter aircraft becomes visible. In general, when a pilot notices the other aircraft, it takes around ten seconds before he decides on action and initiates an evasive manoeuvre. The same is true for the pilot of the high-speed fighter aircraft. Given the speed at which both aircraft are approaching, the military pilot too will have little time to detect a small aircraft and take evasive action.

▲ Figure 7: Visibility of a military fighter aircraft related to time and reaction time for an evasive manoeuvre (source: Australian Transport Safety Bureau (ATSB), *Limitations of the See-and-Avoid Principle*, 1991, reprinted 2004).
