Near mid-air collision between F-16 and Tecnam

The Hague, October 2025

The Dutch Safety Board

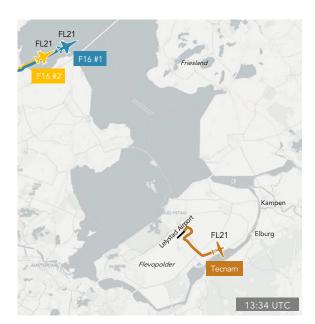
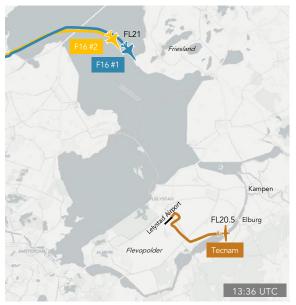
▲ Figure 1: Approximate aircraft positions at 13:34 and 13:36 (source radar data: ATC the Netherlands).

At 13:36, the area controller instructed the formation to climb to 3,000 feet due to VFR traffic flying in the area of Lelystad Airport and opposite IFR traffic. The opposite traffic was another F-16 formation that was scheduled to fly at 2,000 feet along the same route from Volkel to Vlieland. At the time of the area controller's instruction, this formation had not yet departed from Volkel Air Base.

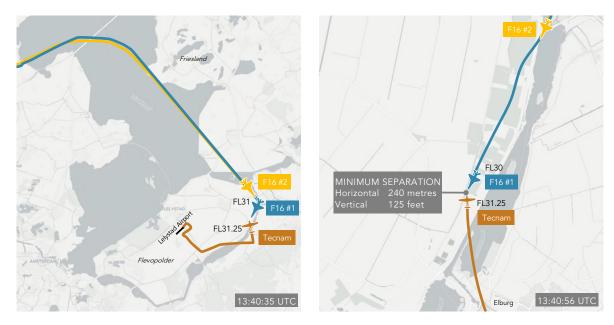
Between 13:36 and 13:40, a colleague relieved the area controller of his duty. At 13:40, near Kampen, the F-16s changed course to a southwesterly direction, see Figure 2. At that time, the new area controller informed the pilots of traffic flying two nautical miles (NM) right in front of Shark 1, at the same altitude. Shark 1 observed an aircraft at 3,000 feet on the AIFF interrogator. This aircraft was however not displayed on his radar screen. Shark 2, flying approximately two miles behind Shark 1, did see this aircraft on his radar screen and informed Shark 1, indicating the aircraft was flying two miles directly ahead and slightly above the horizon. Shark 2 also relayed the aircraft's radar track to Shark 1 via datalink.

The pilot of Shark 1, considering the F-16's high speed, decided to focus on visually identifying the traffic. Shortly thereafter, Shark 1 spotted three lights and identified a white propeller aircraft with a tricycle landing gear at close distance. The pilot immediately performed an evasive manoeuvre by making a sharp descending turn to the right.

ATC radar data indicated that Shark 1 and the Tecnam passed each other with a minimum horizontal separation of approximately 240 metres and a vertical separation of 125 feet. The groundspeed of Shark 1 at the time of the manoeuvre was approximately 420 knots.

▲ Figure 2: Aircraft positions at 13:40:35 (course change near Kampen) and 13:40:56 (near miss) (source radar data: ATC the Netherlands).

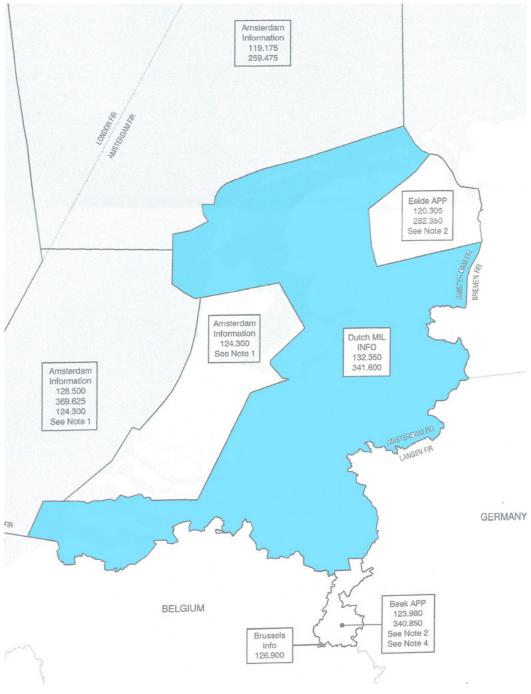
The FISO did not notice a potential conflict between the Shark formation and the Tecnam and did not see the near miss. He only learned of the incident from the area controller. The FISO stated that he could not explain why he had missed the event, suggesting that, given the large work area he was monitoring (see Figure 3), his attention might have been focused elsewhere, despite his low workload.

▲ Figure 3: Airspace under responsibility of the Dutch Mil FISO (blue) (source: AIP the Netherlands – blue area highlighted).

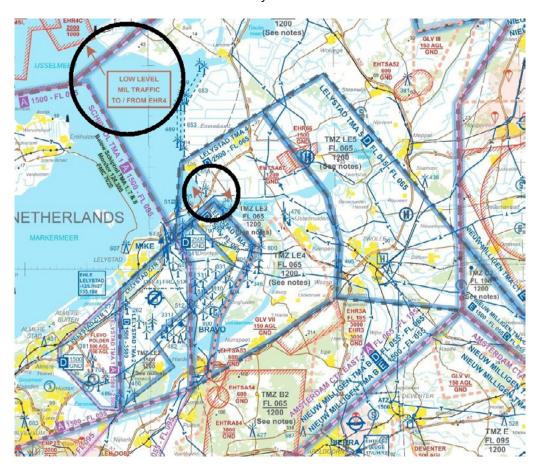
▲ Figure 6: Part of the aeronautical chart with the 'Low level Mil Traffic' warnings highlighted (source: Aeronautical Chart The Netherlands, Edition 2024, LVNL - warnings highlighted).

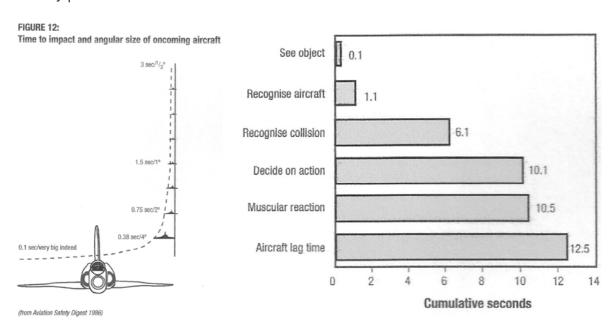
The limitations of the see and avoid principle become even more apparent at higher closing speeds, such as in the case of high-speed military fighter aircraft. Research on this subject shows that, given the speed of a military fighter aircraft, it may only take some seconds before a head-on approaching fighter aircraft becomes visible. In general, when a pilot notices the other aircraft, it takes around ten seconds before he decides on action and initiates an evasive manoeuvre. The same is true for the pilot of the high-speed fighter aircraft. Given the speed at which both aircraft are approaching, the military pilot too will have little time to detect a small aircraft and take evasive action.

▲ Figure 7: Visibility of a military fighter aircraft related to time and reaction time for an evasive manoeuvre (source: Australian Transport Safety Bureau (ATSB), Limitations of the See-and-Avoid Principle, 1991, reprinted 2004).
