**REPORT**  
**OF THE**  
**OPERATIONAL SAFETY REVIEW TEAM**  
**(OSART)**  
**MISSION**  
**TO THE**  
**BORSSELE**  
**NUCLEAR POWER PLANT**  
**THE NETHERLANDS**  
**23 JANUARY – 9 FEBRUARY 2023**  
**AND**  
**FOLLOW-UP MISSION**  
**19 – 23 MAY 2025**

**DIVISION OF NUCLEAR INSTALLATION SAFETY**  
**OPERATIONAL SAFETY REVIEW MISSION**  
**IAEA-NSNI/OSART/216F/2025**

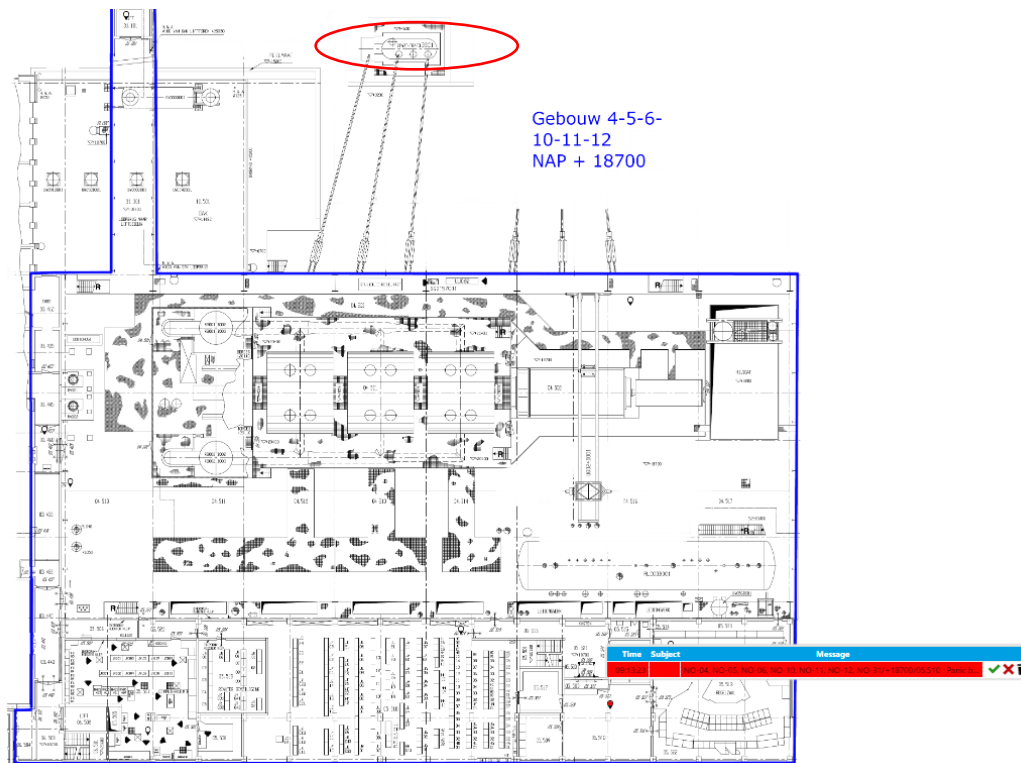
An example of the alarm and map information received by the Main Control Room via email.

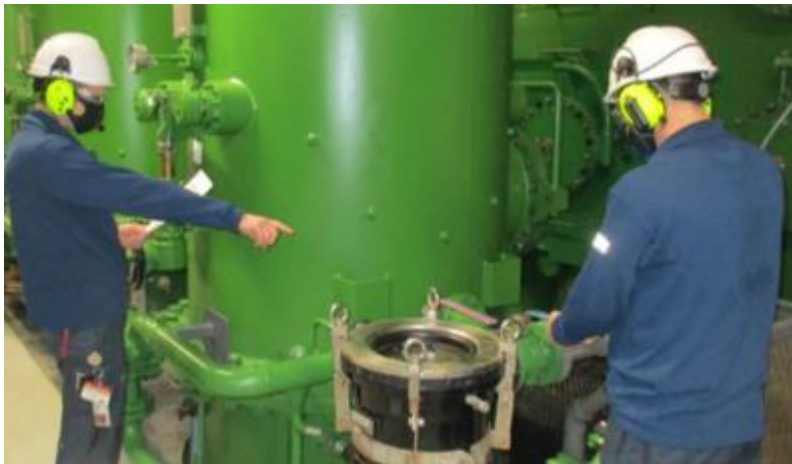
Bluetooth hearing protection with an integrated speaker and microphone in use
