MV “FREMANTLE HIGHWAY”

FIRE ON BOARD

REPORT NUMBER: R-016-2024-DIAM

SAFETY INVESTIGATION REPORT

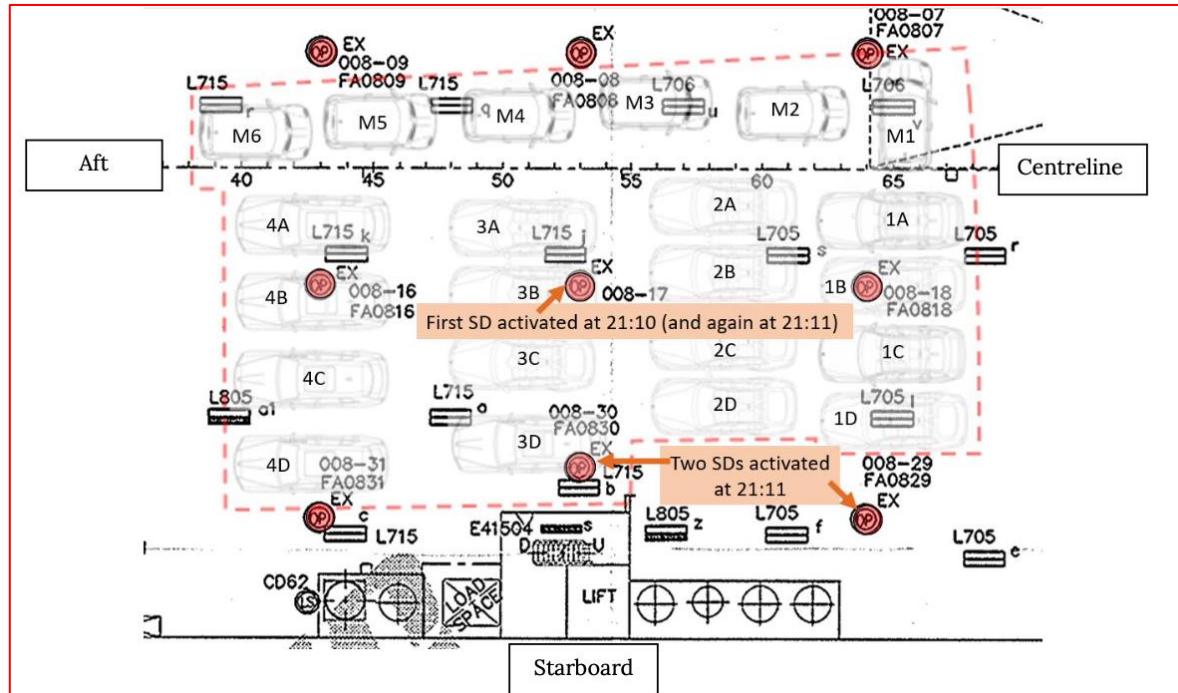
The below figure illustrates the arrangement of the smoke detectors (highlighted red) in the area of concern on Deck 8 (red dashed line). The three SDs that were activated are denoted. The vehicles are also arranged. BMW iX1s comprise vehicles 1A and 1C. Vehicles 1B, 1D, 2A, 2B, 2C, 2D, 3A, 3B, and 3C were all BMW i7s; all BMWs were electric vehicles (EVs). The Minis M1-M6 were stowed to the port of the centerline. 3D, 4A, 4B, 4C, and 4D were Rolls Royce vehicles.

The first alarm (SD 008-17) activated at **23:10hrs LT**. This detector is central to the area of interest and suggests a fire originating close to vehicle 3B.

The second and third alarms are both set for **23:11hrs LT** and are for two SDs on the starboard side (008-30 and 008-29). The initial alarm is promptly followed by alarm 008-30 in the printout. This suggests that this SD was activated before 008-29, despite the fact that both have the same time signature. The activation of these detectors signifies the forward movement of smoke in a forward orientation and towards the starboard side. The distance between these SDs is approximately 10 meters, or eleven frames.

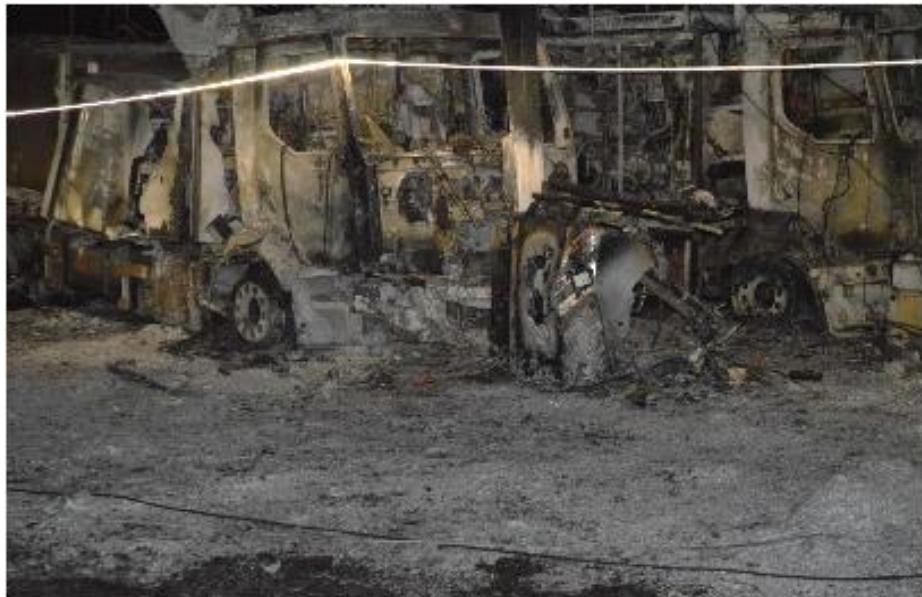
Due to the harmful substances on board, the investigation on board was conducted on a limited basis, under supervision and with the proper personal protective equipment. On the starboard side, the “fire experts’ team” entered the vessel at the pilot entrance on the **5DK**. At the level of the bow, the flexible **6DK** was placed in the highest position. On **5DK** were mobile cranes, transfer cranes and trucks, equipped with an aerial platform stored. Parts of the floor of the **5DK** were covered with solidified aluminum, which had flowed through holes in the decks above.

FIGURE 6: TRUCKS EQUIPPED WITH AN AERIAL PLATFORM ON THE 5TH DECK

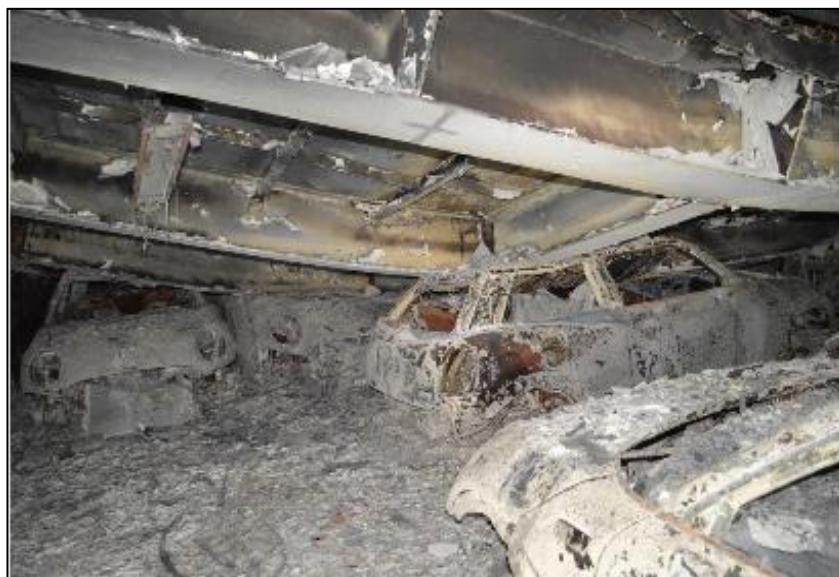
Through the stairwell in the bow of the vessel, the “fire experts’ team” went to the mooring deck on the **7DK**. On the mooring deck lays an EEBD (Emergency Escape Breathing Device). From the previously received statements and interviews with the crew members, the “fire experts’ team” concluded that the EEBD was left by the third officer before he jumped in the sea/water. The life rafts on the mooring deck were still in place at the embarkation stations. Inside at the **7DK**, seen from the bow, the total destruction of the stowed cars was visible, **8DK deck** came down partially and crushed several vehicles underneath.

FIGURE 7: CRUSHED VEHICLES AT 7TH DECK
(Source: Physical inspection O/B - Fire Expert Report)

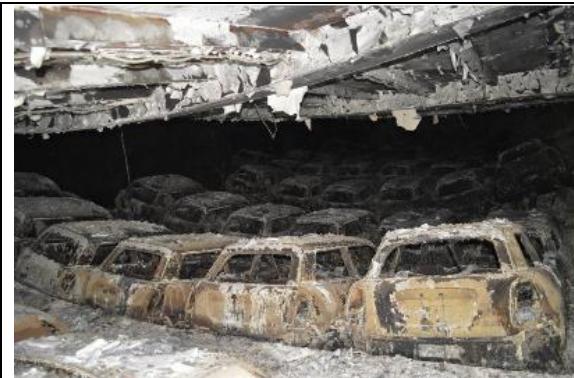
The vehicles on the port side of **8DK** were still identifiable as vehicles. The vehicles on the starboard side are barely recognizable as vehicles; the destruction was enormous, and therefore, it can be considered as the area where the fire started. It was not possible for the “fire experts’ team” to go between the remains of the vehicles. Sections of **8DK** were deformed and other sections had fallen down in their entirety. Traces found on sections of **8DK** such as parts that had fallen from cars, show that the collapse of certain sections of this deck was a result of the fire which developed at a later stage on **7DK**.

FIGURE 8: 8TH DECK PORT SIDE
(Source: Physical inspection O/B - Fire Expert Report)

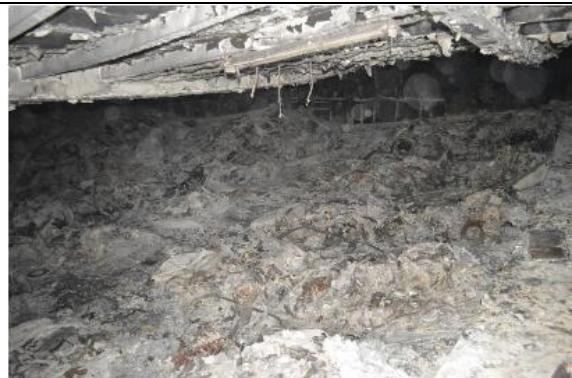
FIGURE 9: 8TH DECK STBD SIDE
(Source: Physical inspection O/B - Fire Expert Report)

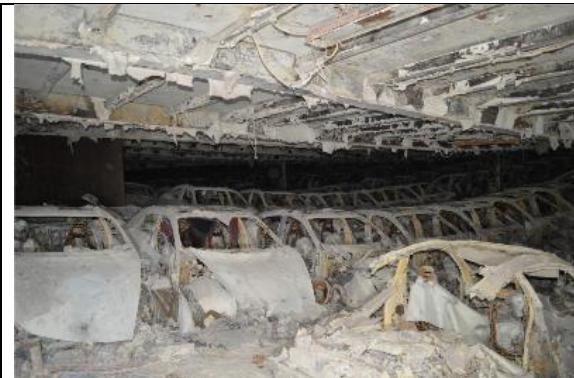
The vehicles on **9, 10, 11, 12DK** were also burned. Although the visible damage to the vehicles on the **12DK** differs from what is visible on the decks below. Probably a lack of oxygen, due to the huge smoke development, affected the burning process on **12DK**

FIGURE 10A: 9TH DECK BURNED CARS
(Source: Physical inspection O/B - Fire Expert Report)

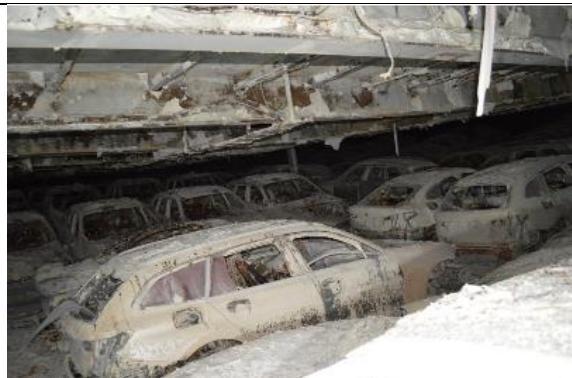
FIGURE 10B: 10TH DECK BURNED CARS
(Source: Physical inspection O/B - Fire Expert Report)

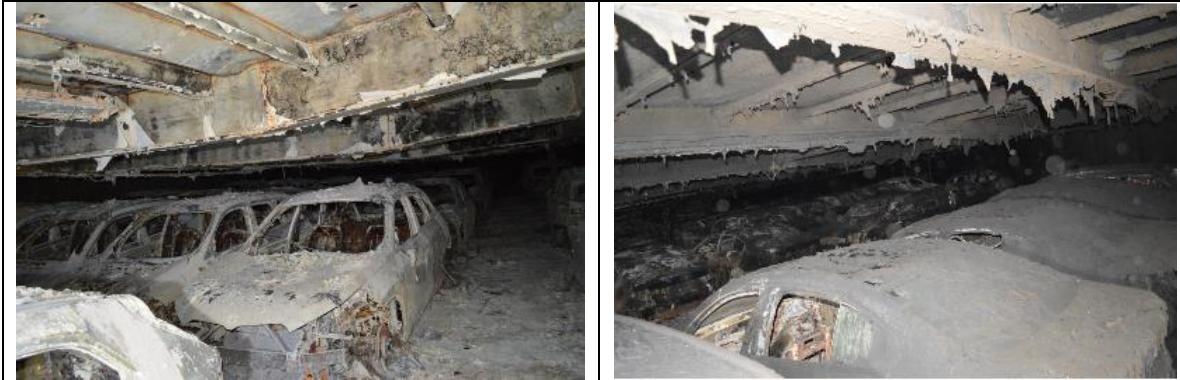
FIGURE 10C: 11TH DECK BURNED CARS
(Source: Physical inspection O/B - Fire Expert Report)

FIGURE 10D: 12TH DECK BURNED CARS
(Source: Physical inspection O/B - Fire Expert Report)

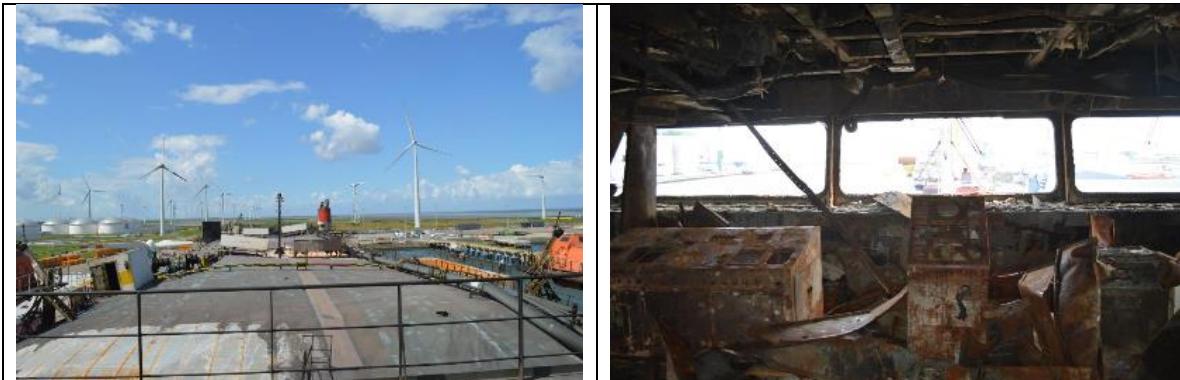
The upper deck was heavily deformed by heat. After initially being convex, the upper deck collapsed. The accommodation and bridge were also completely destroyed by the fire. All possible data carriers, as well as hard copies of records and reports on the bridge, were destroyed.

FIGURE 11: UPPER DECK DEFORMED
(Source: Physical inspection O/B - Fire Expert Report)

FIGURE 12: BURNED EQUIPMENT ON THE BRIDGE
(Source: Physical inspection O/B - Fire Expert Report)

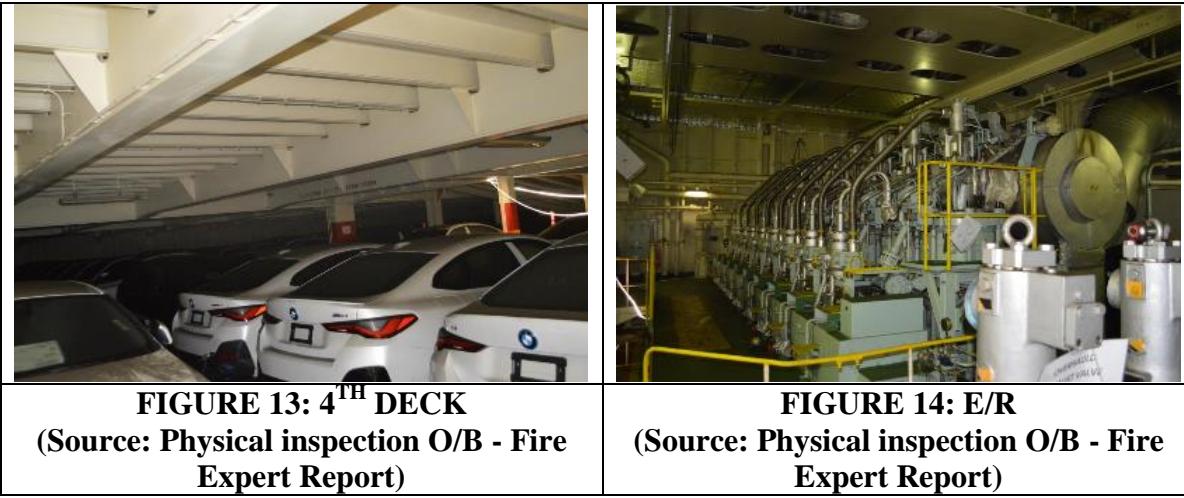
There was hardly any damage below **5DK**, other than the pollution (such as foam or water residue) that occurred during the fire extinguishing operation. **4DK** and the engine room were visited during the survey and were found in intact condition.

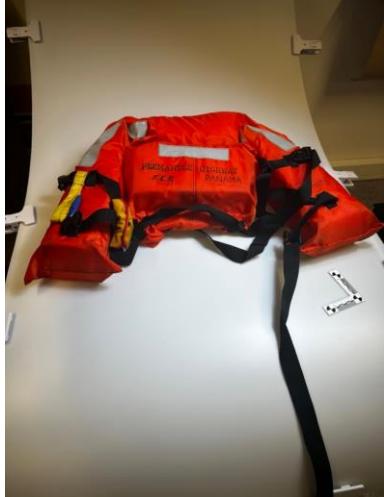
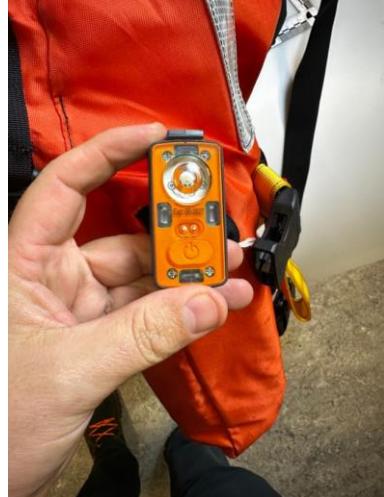
Unfortunately, one of the crew members, an A/B (who was also the first jumper), jumped into the sea/water from the bridge; regardless of the efforts of the medic, he passed away. The official report provided by the local authorities indicates a death during/after the jumping overboard of a 59-year-old man from a great height (30 meters). In the beginning, the lack of obvious injuries makes death by drowning a good possibility, considering it was likely that he swallowed a lot of seawater after jumping and but it was eventually determined that the victim died due to cardiac arrest.

<p>FIGURE 21A: LIFE JACKET USED BY CREW JUMPED INTO SEA/WATER</p>	<p>FIGURE 21B: LIFE JACKET USED BY CREW JUMPED INTO SEA/WATER</p>

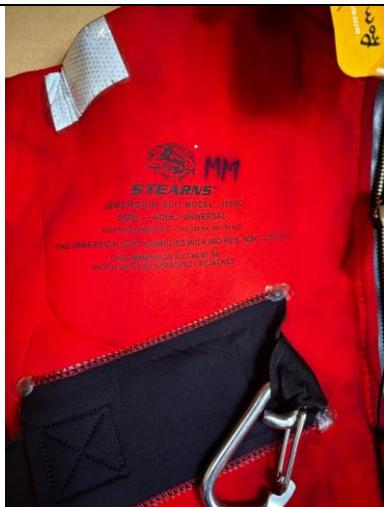
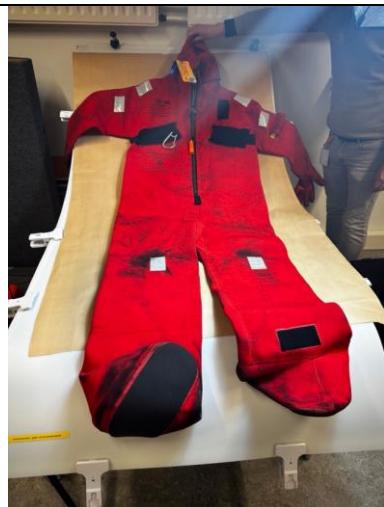
up from the rescue boat. The jumpers had some difficulty getting in a position to jump because they had to climb over the handrails first; they were wearing immersion suits, which restricted mobility.

<p>FIGURE 22A: IMMERSION SUITS USED FROM CREW JUMPED INTO SEA/WATER</p>	<p>FIGURE 22B: IMMERSION SUITS USED FROM CREW JUMPED INTO SEA/WATER</p>

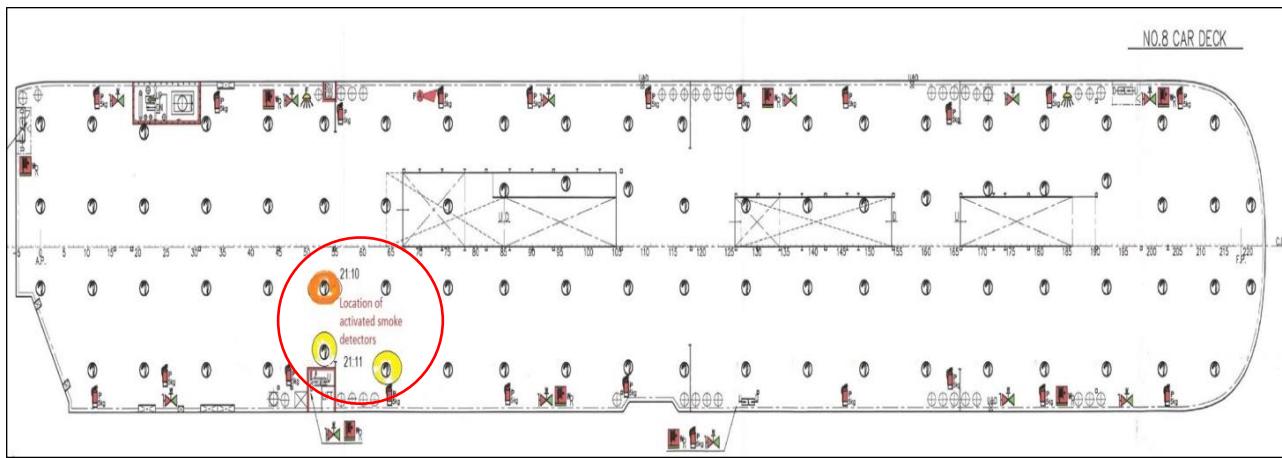
The C/O (in charge of the emergency team) and the bosun went to the 8DK to further investigate the area. Immediately, he observed very heavy smoke rapidly increasing, and the bridge was immediately informed. The Master requested the emergency team to assess the overall condition and to advise if they could attack the fire using the fire extinguishers. The C/O replied that the smoke was thick and dark, and they could not approach the unit in flames. In addition, he indicated that he assumed that the unit on fire is probably an EV because the area where he sees the flames is where EVs are located. C/O with the emergency team, unable to act, returned to the muster station and did a head count. Afterwards, he reported to the Bridge on a radio how many people were accounted for at the muster. The Master confirmed a fire and said to prepare for firefighting and boundary cooling. C/O then confirmed to the crewmembers that the fire alarm was coming from 8DK. He confirmed he could see smoke down below from looking down the ramps. Each top deck, 7 through 12, is connected with ramps in the same locations.

FIGURE 30: LOCATION OF ACTIVATED SMOKE DETECTORS
(Source: Submitted by DSB)

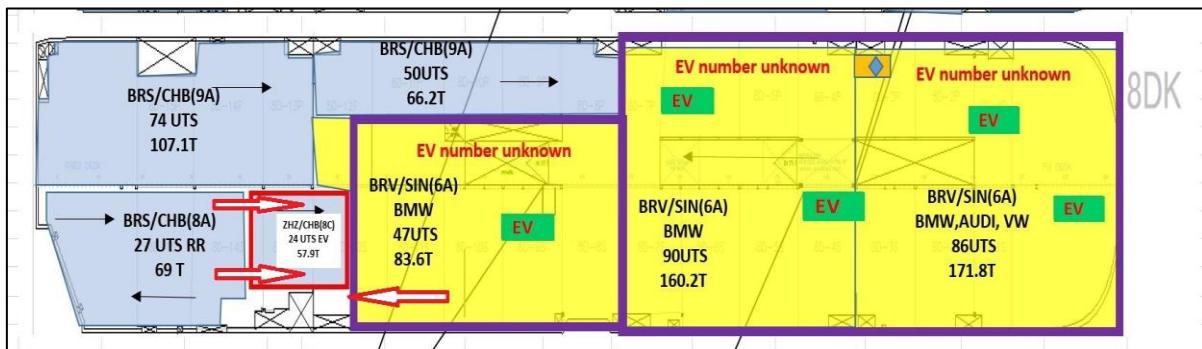
Regarding its location, it was confirmed by the duty AB that the fire was initially located at **8DK hold 4, starboard side, Fr 50-55**, after receiving a fire alarm from a smoke detector in the fire panel, which printout was eventually recovered. **Regarding the fire itself**, it was **firstly observed by the duty AB and subsequently by the 3rd Officer coming from an EV** which stowage position coincides with the first activated fire detector location. The evidence indicates the fire source of ignition was an EV within the block of 24 EVs located at stbd side, aft, deck 8 and likely close to the first activated smoke alarm.

FIGURE 35: LOCATION OF THE EV CARS IN THE AREA IDENTIFIED AS FIRE POINT OF ORIGIN
