MV “FREMANTLE HIGHWAY”

FIRE ON BOARD

REPORT NUMBER: R-016-2024-DIAM

SAFETY INVESTIGATION REPORT

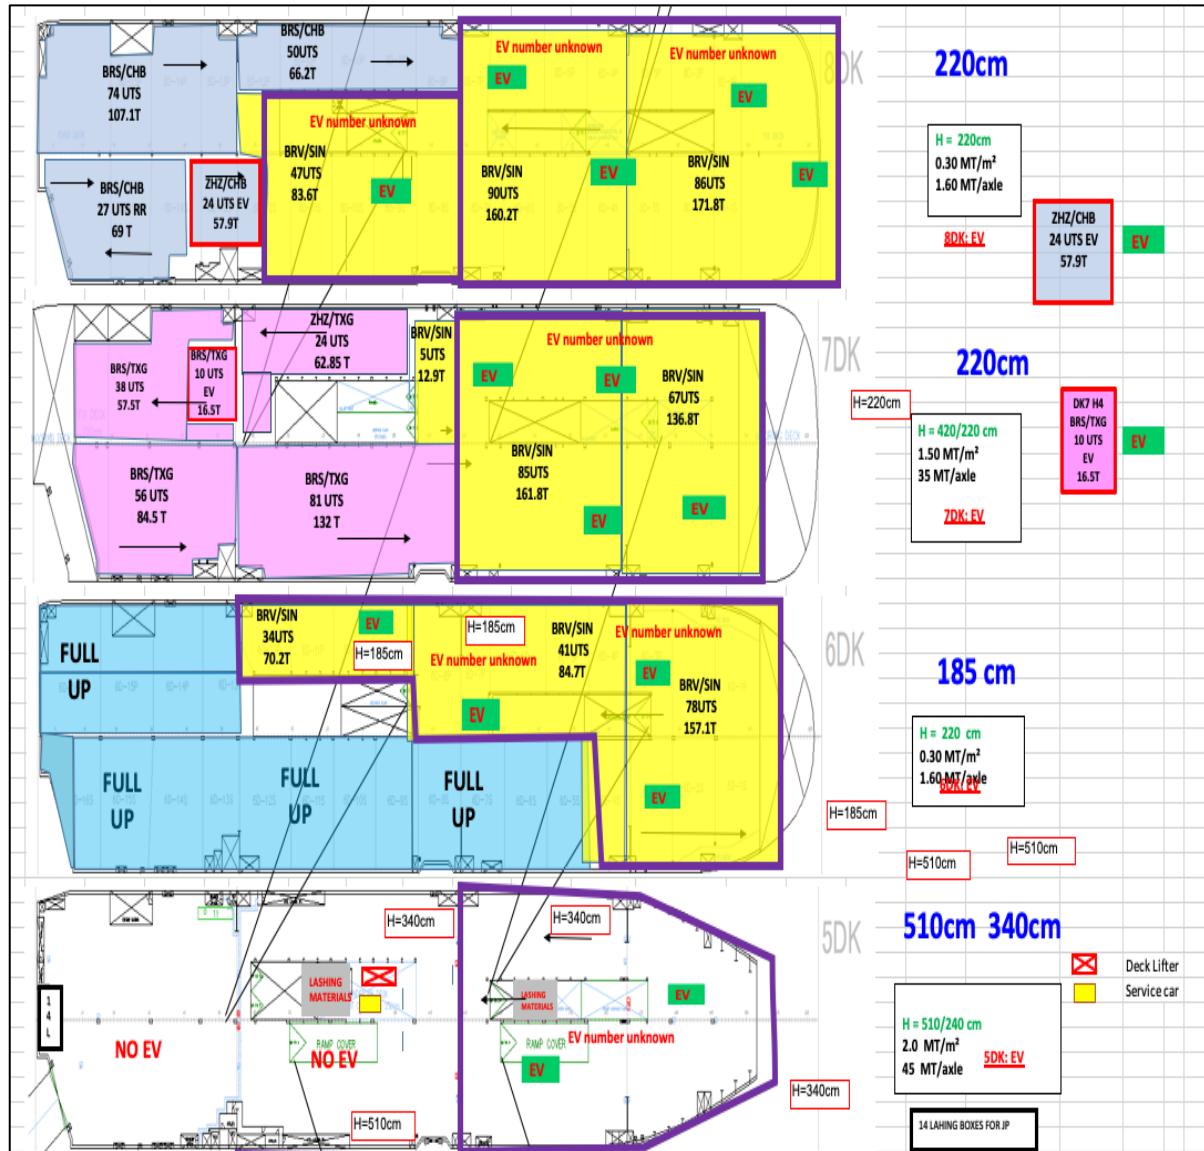
FIGURE 20B: STOWAGE PLAN PART B
(Source: Submitted by Operators)

1. The Stowage plan for Deck 8, after loading at Bremerhaven is shown in **Figure 20B**.
BMW Group cargo is indicated to fill all four holds of Deck 8 with the exception of some Audis and VWs forward in Hold 1.
2. According to this document 27 RR units (we understand RR to denote Rolls Royce) were loaded in Bristol for discharge in Chiba. These were stowed aft on Deck 8 (starboard side).
3. A group of Electric Vehicles (EVs), (Figure 3, red box) were stowed on Deck 8 to starboard of the centreline at the Hold 3/4 boundary. These EVs were loaded in Zeebrugge for discharge in Chiba.
4. We consider that the 74 Unit and 50 Unit blocks on the port side relate to Minis, based on the number and weights of the units and the fact they were loaded in Bristol, again for discharge in Chiba.
5. The BMWs loaded in Bremerhaven completed the loading of Holds 2 and 3 on Deck 8, and some of Hold 1.

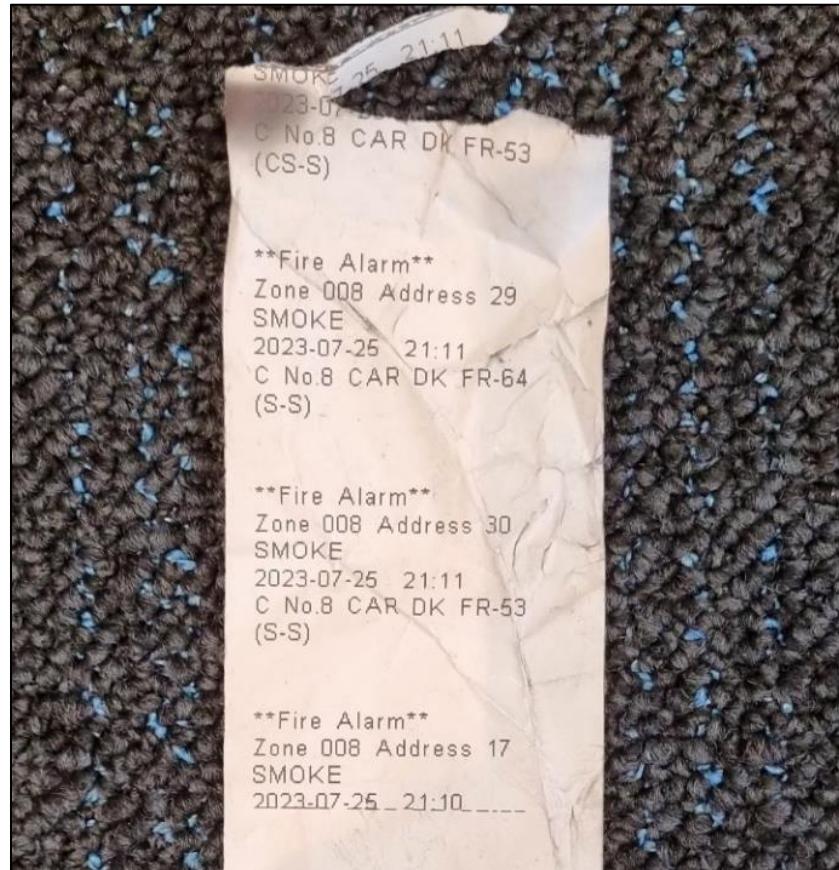
FIGURE 28: PRINT OUT OF FIRE ALARM
(Source: Obtained from a crewmember overall/immersion suit by the Dutch police on July 26th, 2023 and shared with the DSB/PMA)

On **July 25th, 2023**, at approximately **23:00hrs LT**, the vessel was in a location (53 46 N 006 41 E). The electrician and the engine cadet were in E/R, while the 3rd deck officer and one AB were on the bridge in compliance with the watchkeeping schedule. The 3rd Deck Officer acknowledged the fire alarm on the bridge at **23:11hrs LT** by using the indication panel. The alert signal mentioned area **8DK, hold 4**. Simultaneously, he called the Master, who arrived at the bridge, assumed command, and gave the 3rd Deck Officer and the AB orders to investigate the suspected area.

The 3rd Deck Officer and AB did not take any special FFE/PPE with them, except a radio (to communicate with the bridge), since they considered that there was a high possibility of a smoke sensor malfunction rather than an actual fire. As per crewmembers' statements, they did have some false alarms in the past. However, when they arrived at 8DK, they reported to the bridge that they saw smoke and flames coming from one or more (electric) vehicles while looking inside the deck.

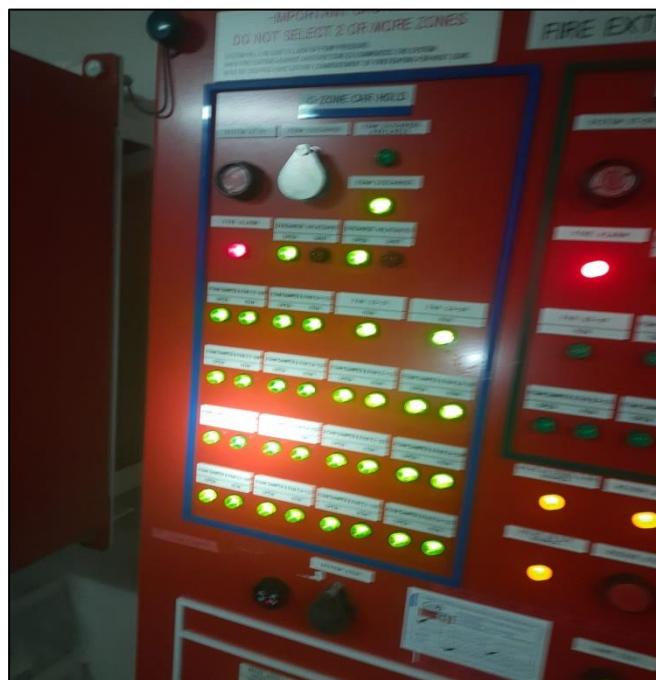
FIGURE 31: FOAM SYSTEM PANEL
(Source: Photograph taken by electrician)

Once the engine and deck departments reported to the Master that all necessary checks had been performed and that they were on standby for the activation of the foam system, the Master ordered the foam system, zone C (also covering 8DK), to be placed on. The activation of the foam system on the subject vessel goes through a certain sequence towards the final part of the activation. The foam system consists of zones A, B&C. The electrician successfully started all the blowers of the foam system and reported them to the bridge accordingly.

Once the foam system started (on about **23:31hrs LT**), the fire teams reported an increase in smoke, most probably coming out of the vent. At the same time, various explosions could be heard from the cargo decks. One explosion was stronger than the others and caused the 12DK to be deformed.

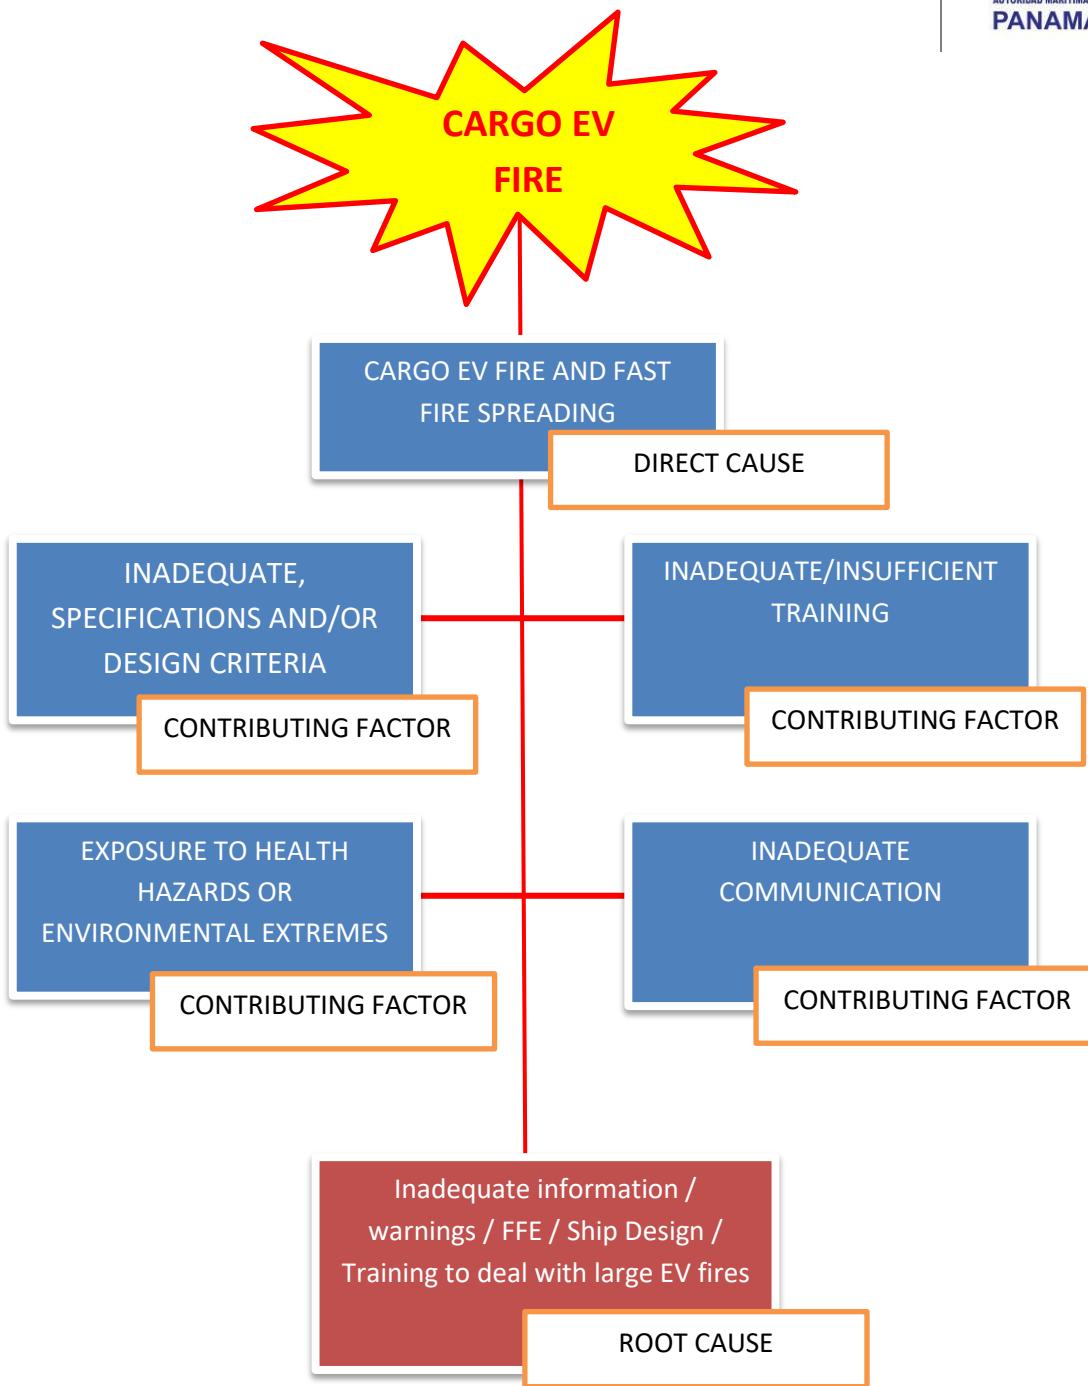
FIGURE 37: CAUSAL FACTOR DIAGRAM

1. CARGO EV FIRE AND FAST FIRE SPREADING (DIRECT CAUSE)

2. INADEQUATE/INSUFFICIENT TRAINING (CONTRIBUTING FACTOR)
